SAFETY ALERT

Cooper VFI failure

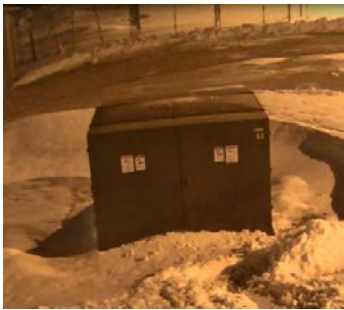
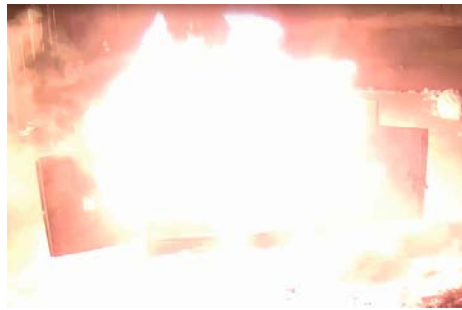
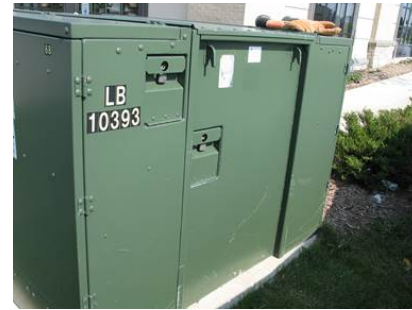
On Feb. 16, 2019, there was a momentary Cooper vacuum fault interrupter (VFI) failure at 3:42 a.m. The unit remained energized until 4:02 a.m., when it failed again; the upstream protective device reclosed twice and then locked open. On the final reclose, the unit violently failed as shown in the picture below. No one was present at this location, and no injuries resulted from this failure. A high percentage of Cooper VFIs have failed over the past few years at We Energies locations; this is the most violent failure yet. All units that failed have done so during the winter months. Cooper has been contacted, and engineering is working with supply chain to verify all Cooper units have been pulled from our stock inventory. These units were only used on the WEC system at We Energies.

Effective immediately, whenever work is to be performed on or nearby Cooper visible-open switchgear, the upstream protective device will be placed in a non-reclosing state, and a hotline caution energized clearance will be required. Remember that only SFU qualified switchers can switch in these units.

When a lockout occurs on a line containing any of these devices with no cause determined and the fault distance is within range of these units, the unit shall be inspected prior to re-energization for any signs of defects.

If a momentary fault occurs on a line containing any of these devices, with no cause determined and the fault distance is within range of these units, the upstream protective device shall be put on a hotline caution energized clearance and the unit inspected for any signs of defects.

A proactive replacement plan has been initiated to remove this style of switchgear from our system. While we implement the replacement plan, we need to remain vigilant until all these Cooper devices have been removed from our system.
