**Title**    **Suspect G&W Viper Reclosers - Recall**

**Issue Date:**    **April 15, 2014**

**Purpose**    **The purpose of this alert is to identify suspect G&W Viper Reclosers, and to locate uninstalled units for return to the vendor.**

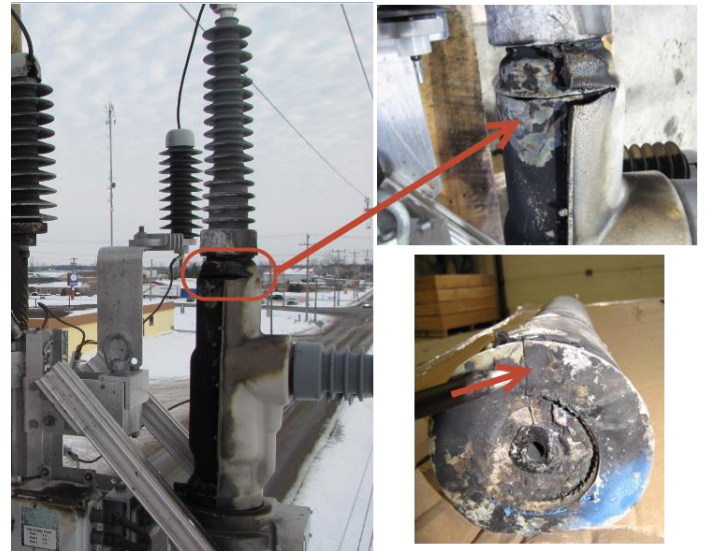
**Details**    There have been 2 recent G&W Viper failures on Hydro One's system. These units have been identified by G&W as part of a potentially faulty batch of reclosers. The failure is due to an electrical breakdown and results in the formation of a mechanical crack at the top of the module, just below the ANSI interface as shown in *Fig 1*. The problem stems from rapid thermal expansion and contraction, and has been narrowed down to units manufactured within the 3 month window of March 2013 to May 2013.

*Fig 1: Failed G&W Viper*

- Set the recloser aside, tag it, and flag the Technical Contact below for return of the unit to the manufacturer.
- Fill out [the attached information](#) to assist with the investigation.

- Fill out [the attached information](#) to assist with the investigation, and flag the Technical Contact
- Option 1: The unit can be replaced with a newer G&W Viper manufactured outside of the suspect date range.
  - Replacement orders and return of faulty reclosers can be organized through the Technical Contact
- Option 2: The recloser can be bypassed until the investigation has finished (anticipated resolution date June 2014).
  - Confirm with the Dx Planner and with Project Management the feasibility of this option.
  - Alternatively, discuss with the Technical Contact the feasibility of AC Hipot testing units which have not already been put into service.

- Set up an Exclusion Zone of 3m
- Replace the faulty unit once a new recloser is ordered, and at the next available outage
