SIF Alert: FINAL communication

Title:	Fresno Flash Burn Incident
Purpose:	Reviewing this Serious Injury and Fatality (SIF) Potential investigation, will allow us to learn what improvements need to be made to provide workers greater capacity to perform their work safely. Please inform your employees of the incident take-aways at your next safety tailboard.
Incident summary: CAP 121718149	<p>On July 12, 2021, at 21:34 hours, the Woodward 2102 circuit breaker in Fresno relayed and opened causing an outage to 3,380 customers. A Troublemaker from the Electric Operations Fresno Division Restoration department was dispatched by the South Distribution Control Center (DCC) Operator to troubleshoot the section of Woodward 2102 that was de-energized.</p> <p>At 22:23, 49 minutes after the original event, the Woodward 2106 circuit breaker relayed and then reclosed and opened, resulting in a circuit breaker lock-out state, causing a sustained outage to 1735 customers. The trouble was later determined to be at the same underground 600 Ap 3-way Trayer switch.</p> <p>The Troublemaker the saw power go out, then noticed a flash and smoke coming from an enclosure across the street. He then drove to t

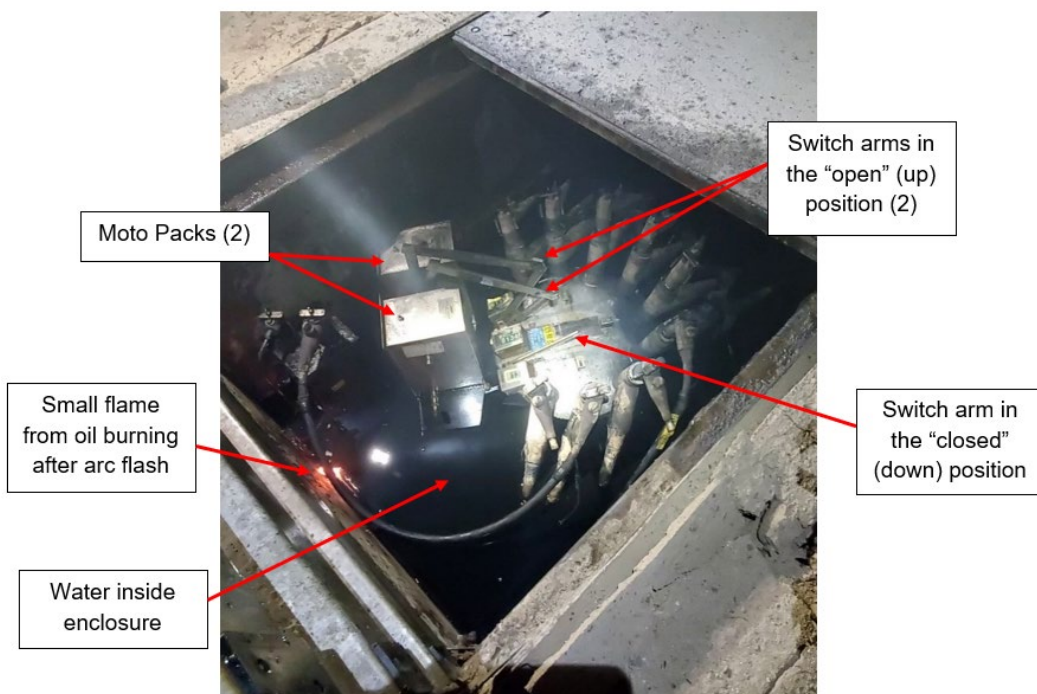
Cause:	<p>AC-1: There is not a formal requirement in procedures for 3-way communication between the DO and Troublemaker in instances where a circuit with FLISR experiences a fault and FLISR automation may be in-process.</p> <p>CC-1: Procedures and associated training for Apprentice and Journeyman Troublemakers and Distribution Operators (DO) do not discuss the inability to fully disable FLISR until all automation sequences are completed, and the need to remain clear of equipment until the DO confirms FLISR is disabled.</p>
Summary of findings:	<ul style="list-style-type: none"> • There is no requirement for formal 3-way communication between the DO and Troublemaker in instances where a circuit with FLISR experiences a fault and FLISR automation may be in process. • There is a lack of knowledge by the Operators and Troublemakers regarding the inability to immediately and completely disable FLISR. • Troublemakers must remain clear of the equipment while the system is running and until FLISR is confirmed to be disabled by the DO. • When experiencing lockouts on circuits equipped with FLISR, the Distribution Operators need to disable FLISR on the associated tie switches involved in the scheme. • The Trayer 600 Amp submersible switch showed signs of arcing inside the housing and melted holes near the bushings. This indicates the oil was likely low and not providing adequate dielectric insulation for the internal energized switch gear components. The switch was built 24 years ago in 1997 and has a 30-year maintenance free life per the manufacturer.

Image 1: Failed 600 Amp Trayer Switch inside enclosure

Corrective actions summary:	<ul style="list-style-type: none"> • Revise Utility Procedure TD-2700P-05, FLISR Operating Guideline / Procedure and Utility Procedure TD-2908P-01, Distribution Switching Procedure to: <ul style="list-style-type: none"> - Require formal 3-way communication between the DO and field personnel during outages when FLISR circuits are involved.

- Add language that FLISR automation cannot be stopped immediately and is programmed to complete automation sequences which can allow it to close. When FLISR is running, the Operator cannot disable until it is in idle state.

- Add an instruction for Operators to disable tie circuits when they get a circuit lockout.
- Add language instructing Operators to not allow Troublemakers to approach equipment until the DO confirms FLISR is idle and the SCADA screen indicates “disabled” status.

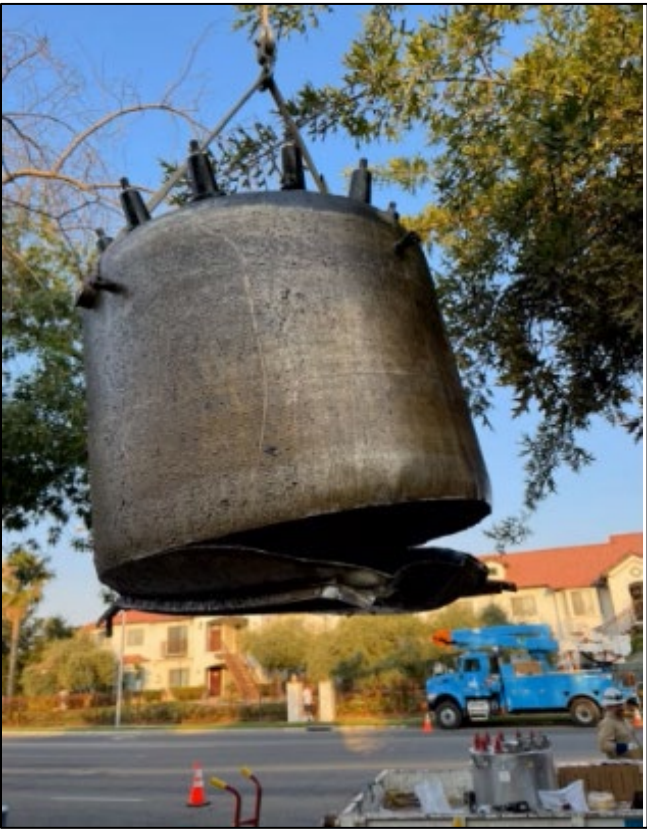
Image #2: Failed 600 Amp Trayer Switch with bottom tank weld rupture.
