SIF Alert: INITIAL communication

Title:	EO Contractor Fall from Bucket Truck, Bakersfield
Purpose:	Reviewing this Serious Injury and Fatality (SIF) Potential event, CAP 123035808 will allow us to learn what organizational improvements need to be made to ensure job task hazard controls provide workers greater capacity to perform their work safely. Please inform your employees of this incident as part of your next safety tailboard.
Preliminary information:	<p>On 2/28/2022, a 5-person contract Electric Distribution crew from PAR Western Line Contractors (PWLC) was tasked with replacing crossarms and installing cutouts on distribution poles located approximately 20 miles north of Bakersfield in the foothills. A Distribution Inspector from Pro-Energy who regularly accompanies the crew was also on-site to monitor the work.</p> <p>At approximately 10:45 am, after completing a crossarm replacement, two linemen who were in the large bucket on the boom truck, lowered themselves down to speak with the Foreman about installing the cutouts. The Foreman had climbed up on the boom truck catwalk and was standing on the top of the truck's fixed stair that is used to get in and out of the bucket. A

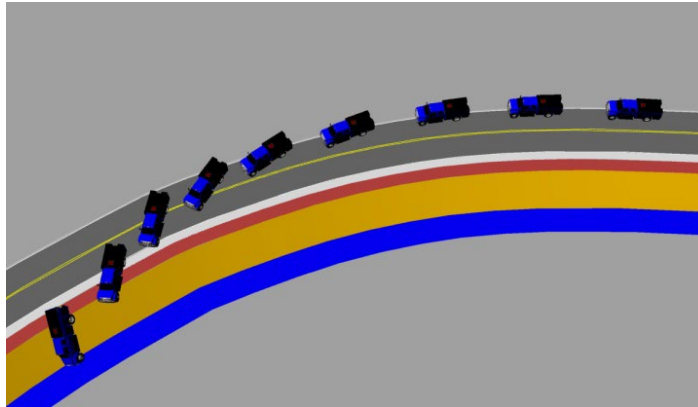
Figure 1: Graphic of vehicle departing and returning to the roadway

- Take your foot off the accelerator and allow the vehicle to slow down gradually
- Do not apply full braking! Use soft applications of the brakes, natural decelerations, and downshifting to bring the vehicle to a safe speed or stop
- Under soft shoulder conditions, feather the accelerator to help maintain control of the vehicle while slowing.
- Once the vehicle has been stopped or been brought down to a safe speed, gently steer the vehicle back onto the road surface using a lower gear to assist in overcoming the surface drop off or soft shoulder.

- Do not attempt to steer back onto the road surface at full speed or under acceleration.
- Do not make any sudden or drastic steering movements.
- Do not apply full braking.
- Do not attempt to accelerate up and over the surface drop-off.
- Do not forcefully turn the steering wheel toward the center of the roadway. This may cause the vehicle to roll over or enter an uncontrollable skid across the highway that will lead to a rollover.
