TLine Incident Alert

Safety Advisory

Topic:	MacLean Socket ball Link_ Faulty Cotter Pin (Key)
LOB:	PG&E: Electric Operations Employees & Contractors
Initial Learnings:	<p>1.The post-incident examination and testing of the socket ball link and cotter pin at PG&E's ATS facility revealed that the cotter pine tines were not fully spread.</p> <p>2. After further analyses of several socket links and cotter pines, we have determined that MacLean socket ball link (material code 18-0189) may have faulty cotter pin configurations when distributed from the manufacture.</p> <div data-bbox="311 565 697 936">

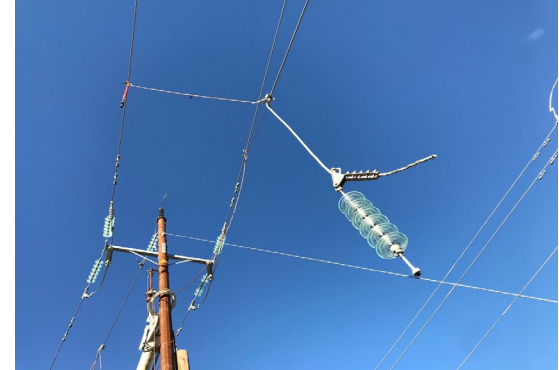
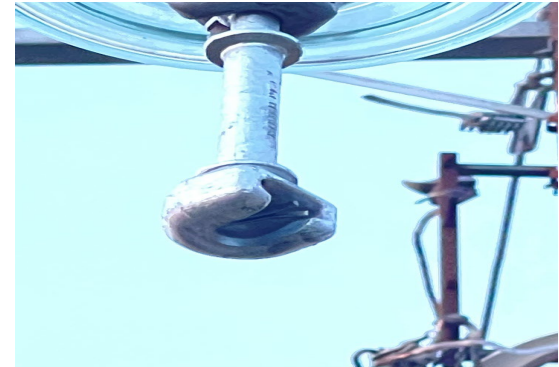
Incident:	Unplanned Outage
LOB:	Electric Operations- Transmission
Incident Description:	<p>Event Description</p> <p>On June 1, 2022, at approximately 1515 hours, A five-man Contract TLine crew was tasked with replacing pole number 00/01 on the Vaca-Dixon #2 60kV circuit. Once the new pole was set next to the existing pole, each phase was moved from the existing pole to the new pole. The circuit was grounded on both sides of the pole at the work location as well as one span away at pole 00/02.</p> <p>Once all three phases were caught off in dead-ends, the crew removed rigging and started installing jumpers. When the employees working on the center phase twisted the dead-end shoe to point the tail up to be connected to the jumper, the phase came free from the pole landing on the energized substation buss approximately one hundred-fifty feet to the west. This resulted in an unplanned outage.</p> <p>Upon initial inspection, it was determined that the ball hook that was fully seated and pinned failed due to a faulty cotter pin configuration. The cotter pin was still in the socket ball link that was suspended in the air and the ball hook was laying on the ground.</p> <p>There were no injuries as a result of this incident.</p>

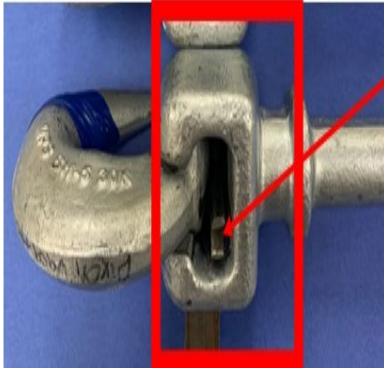
</div> <div data-bbox="768 549 935 707"> <p>Cotter Pin Tines Not Fully Spread</p> </div>

Actions to Take:	<p>Actions:</p> <ol style="list-style-type: none"> 1. Inspect current inventory of Maclean socket ball links and remove faulty, suspect links that do not have the cotter pin fully spread. 2. All suspect MacLean socket ball links shall be removed from service and boxed up. Please contact Tyler Gayski (707) 485-4972, TBG2@PGE.com to arrange pick up. In addition, please email Tyler Gayski with current inventory of MacLean socket ball links (provide details of how many suspect socket ball links) 3. IF, available, please utilize one of our other manufactures such as Hubble or Lindsley. 4. As always, ensure a detailed inspection of all equipment is preformed prior to engaging work, this includes equipment in service. 5. Communicate this Safety Advisory to all PG&E Electric Operations Employees & Contractors.
Contact:	Tyler Gayski, Supervisor TLine Safety (TBG2)

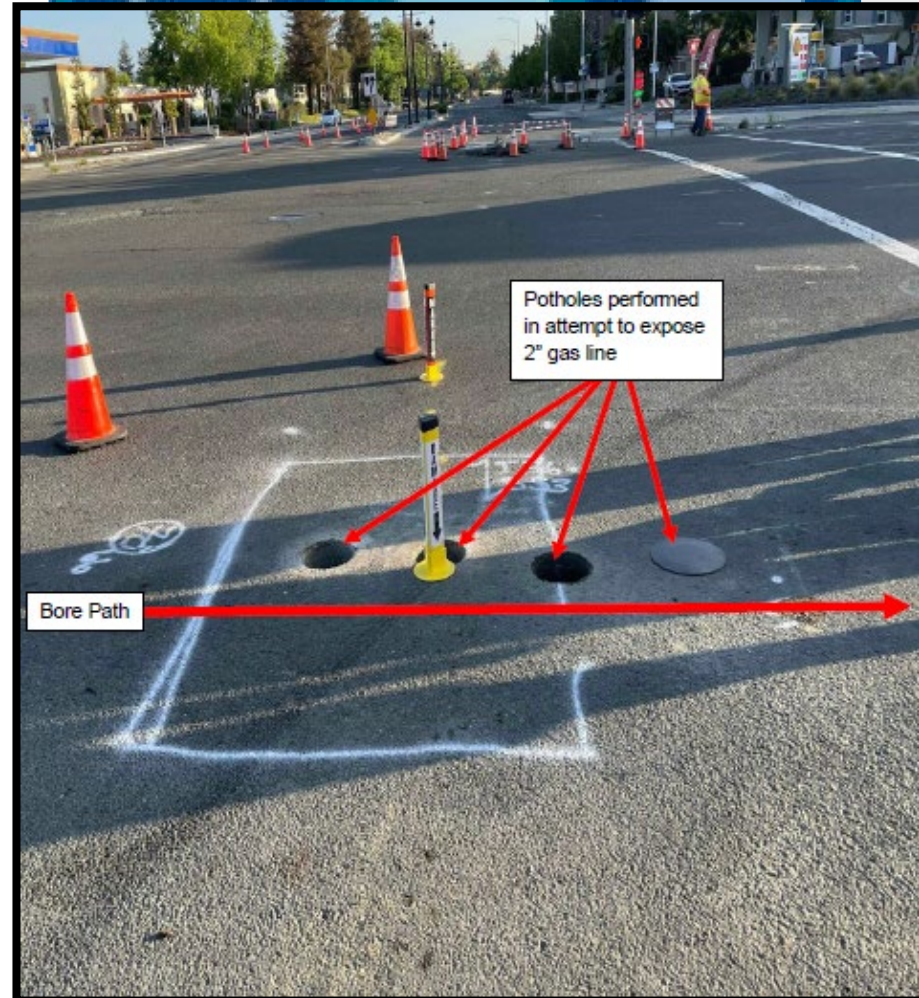
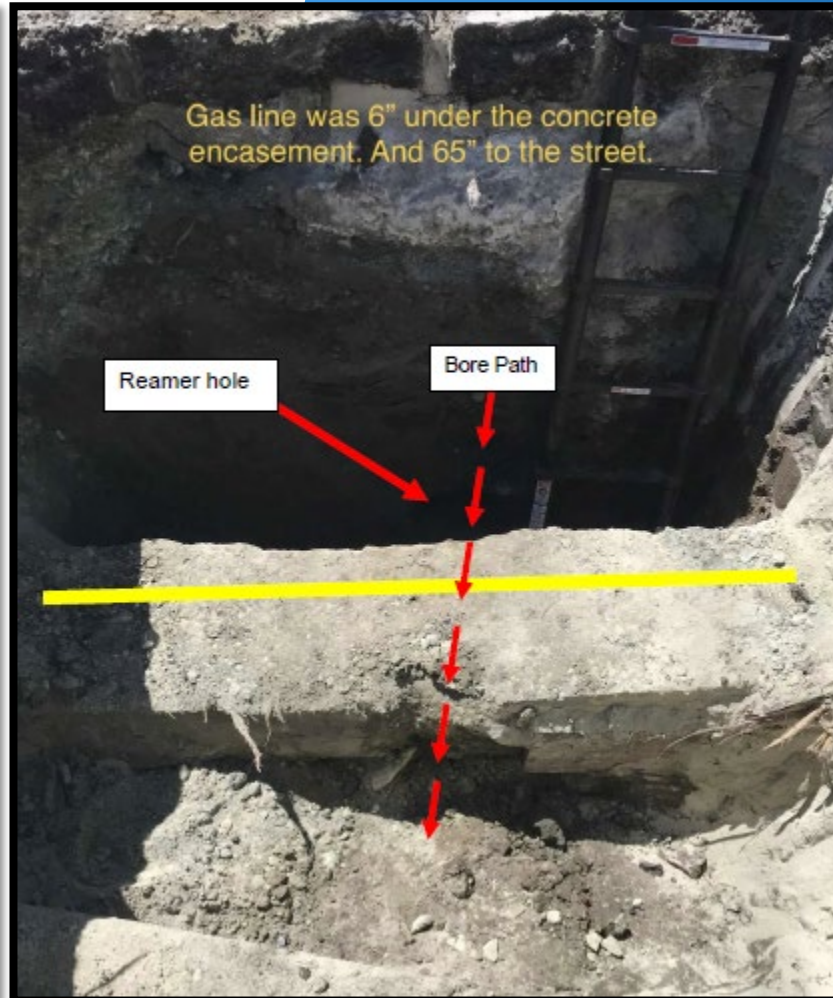
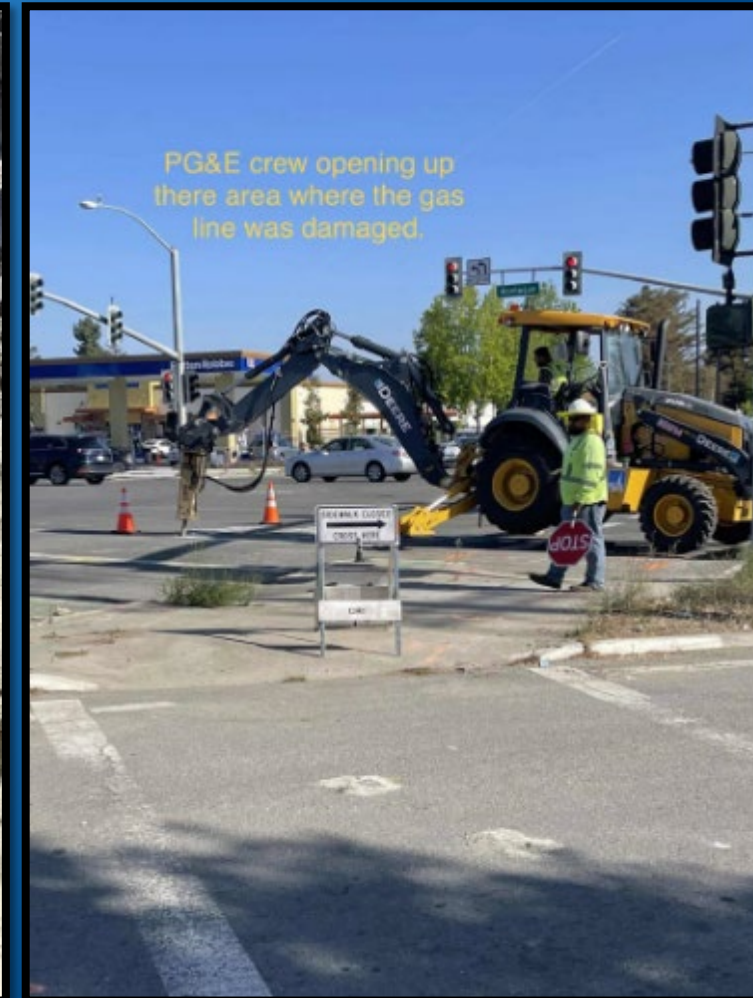
An MGE Underground civil crew was in the process of horizontal directional drilling a location in San Jose when, during the pre-reaming process, a subsurface gas installation was struck, damaged, and ruptured. The location is USA'd and was potholed. While potholing the marks placed by the gas facility locator, the pothole crew discovered a concrete encasement. Numerous attempts of potholing periphery and belly of the encasement were made, and the crew never did locate the gas facility. No attempts were made to contact the gas facility operator for more information, nor was the approximate location verified, the crew made the fateful assumption that the subsurface gas installation was in the concrete encasement. This assumption quickly unraveled when they discovered the gas line during the pre-reaming process – ultimately causing significant damage to the gas facility.

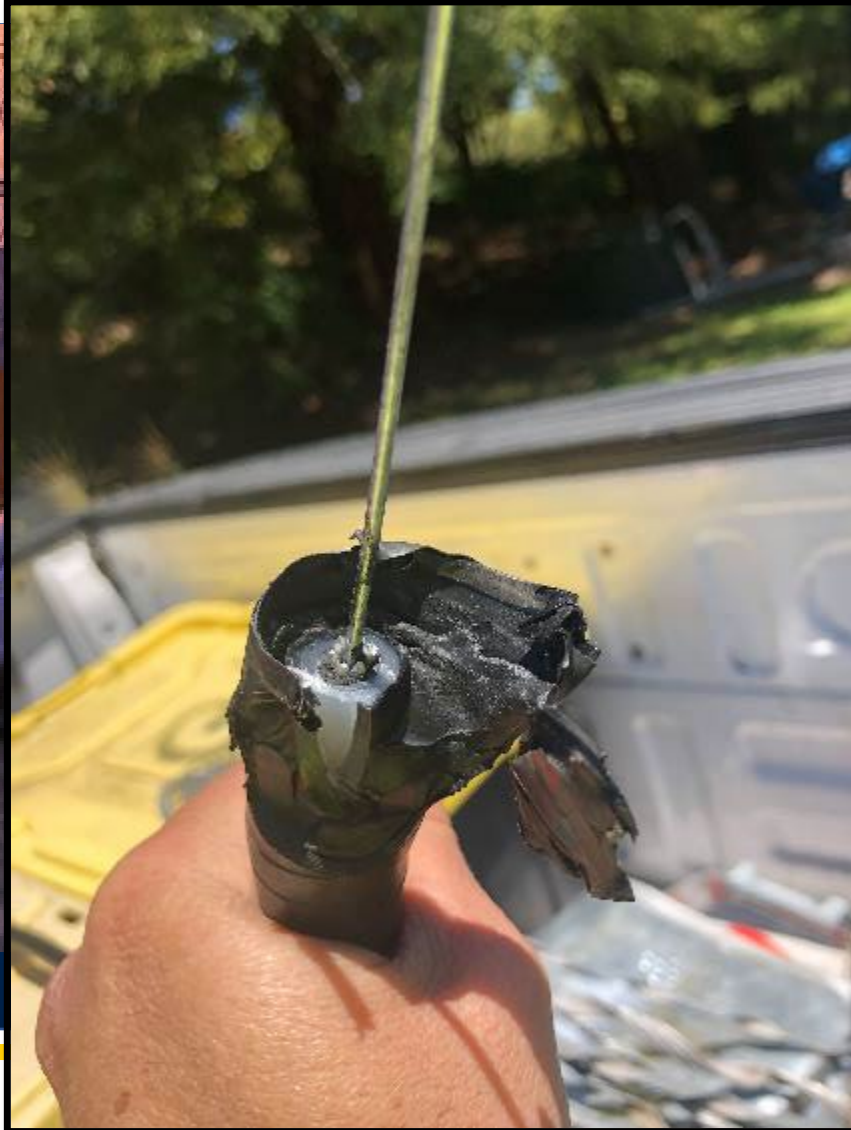
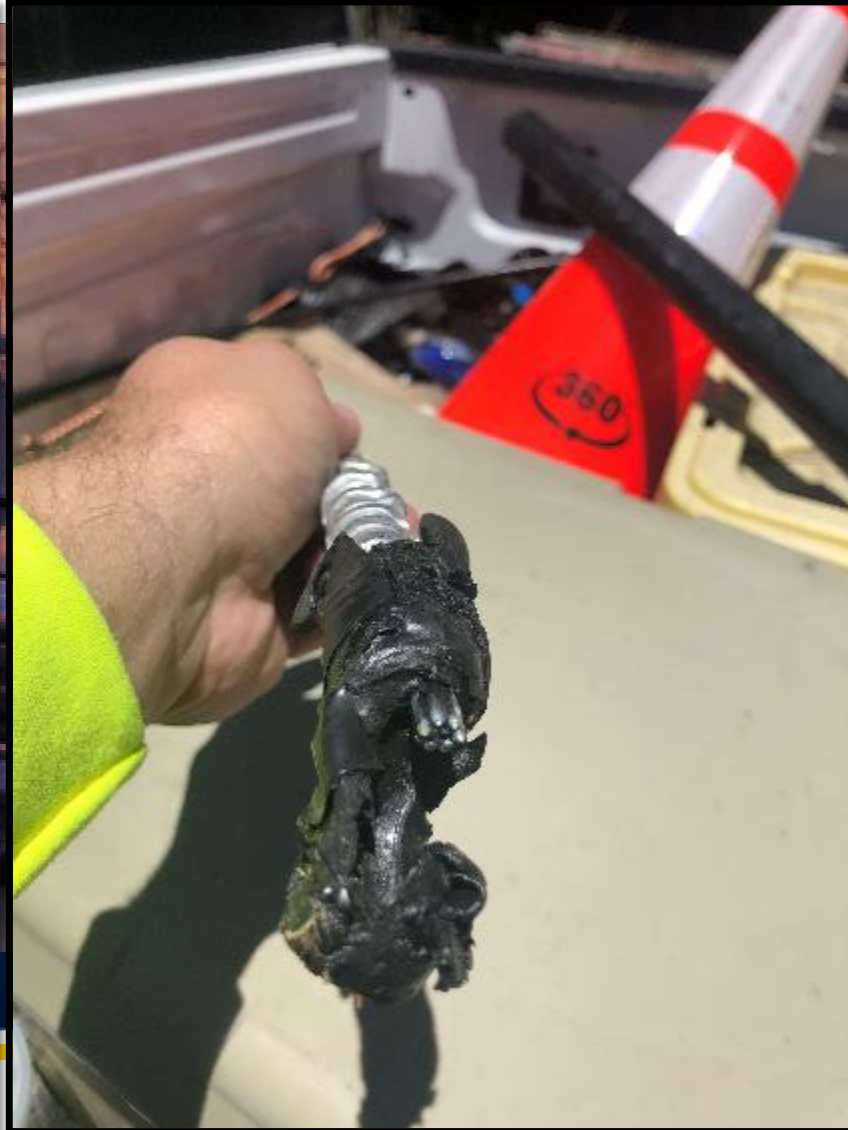
Crew was replacing a pole on a cleared and grounded radial tap line. While the crew was transferring conductor, a full tension splice about ten feet out from the source side, and 438' away from the crew work location, failed and pulled apart. This resulted in the conductors on the take-off pole slapping together and caused an unplanned sustained outage, no damage to main line conductor, all repairs were made on the main line tap, A PG&E Troublemaker then restored all of the unplanned outage customers affected. Per the PG&E inspector, the outage was 30 to 40 minutes in duration.

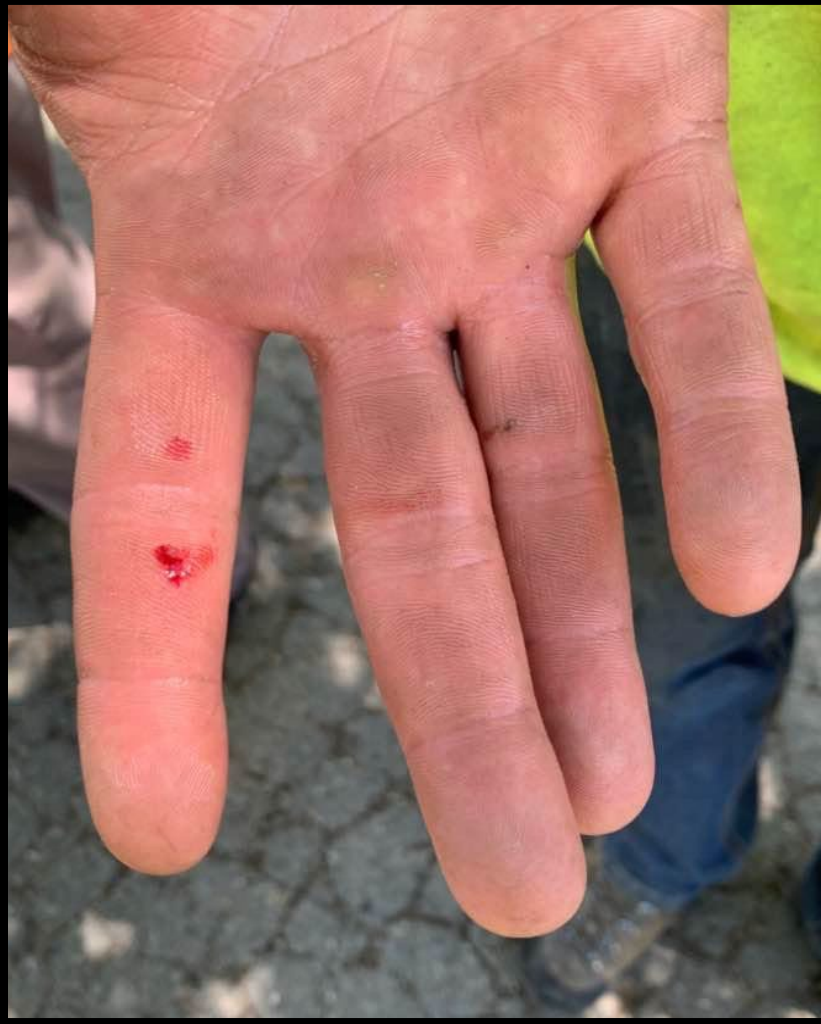
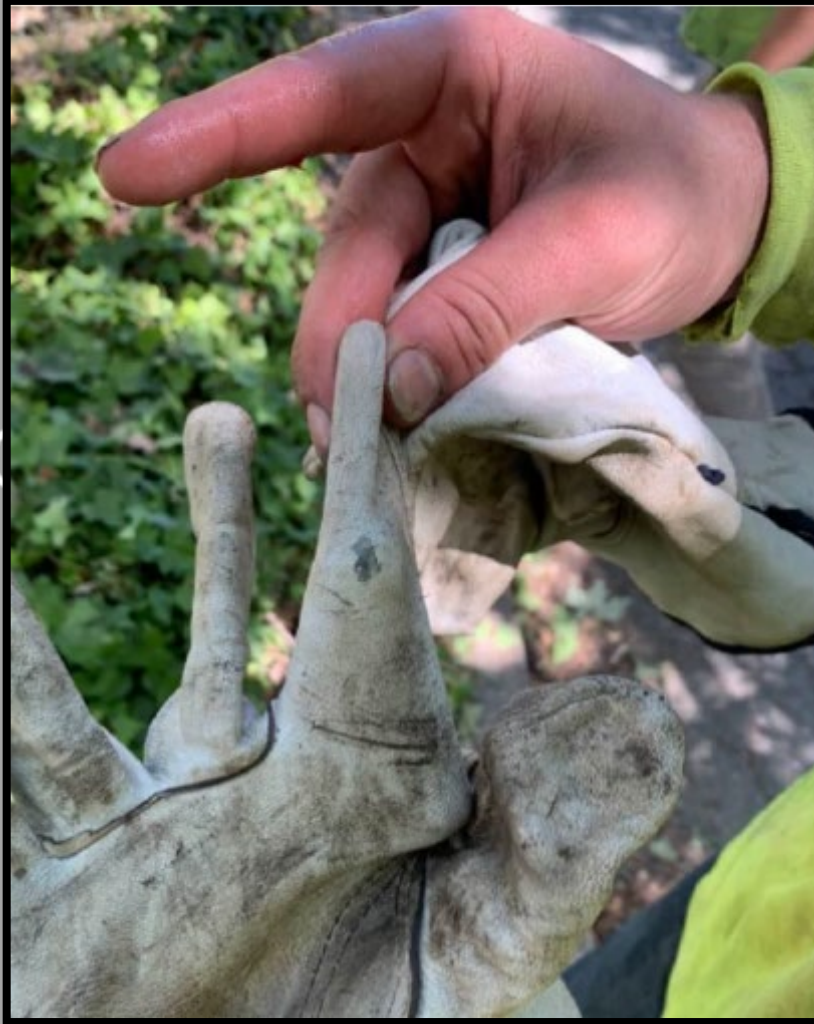
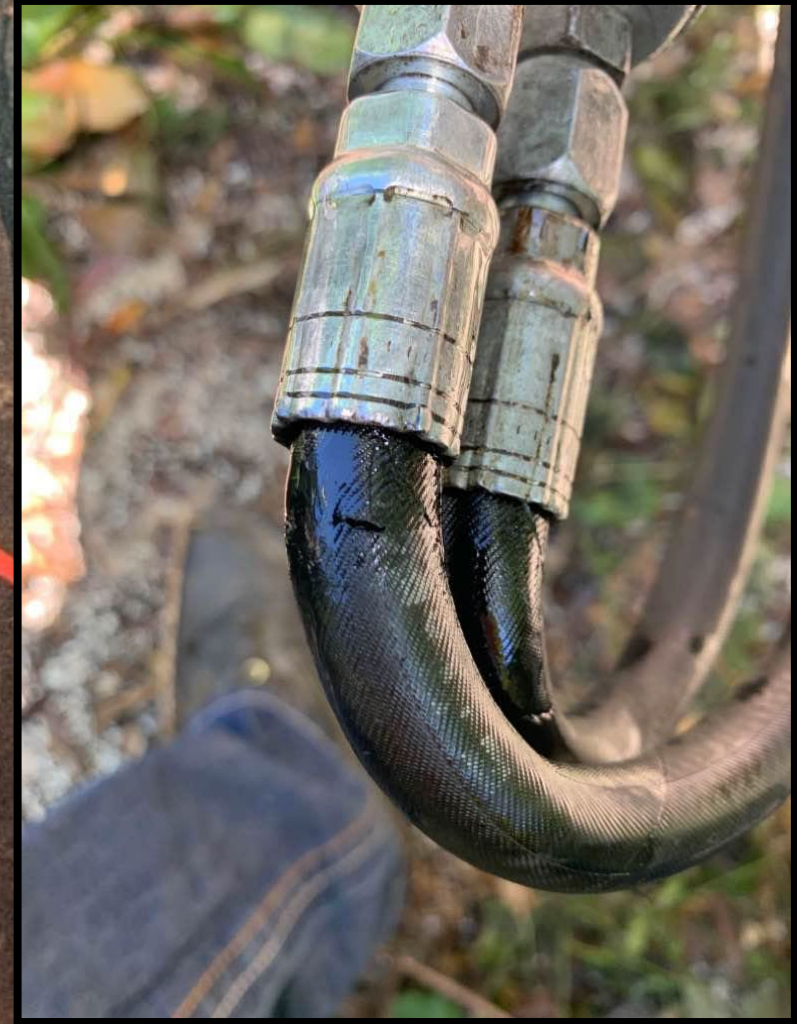
An Alvah 4-man crew was working on a reconductor project in Berkeley, CA to replace a pole, and were in the process of filling and tamping around the perimeter of the pole to achieve compaction. The crew member operating the tamper was holding the tamp at the point of connection between the tamp and hydraulic whip hose as he was tamping a lift that was approximately 5 ft deep around the base of the pole. The lineman was wearing his leather work gloves, as well as all necessary PPE. While using the hydraulic tamp, one of the hydraulic hoses blew and hydraulic fluid injected through his glove and into his right index finger.

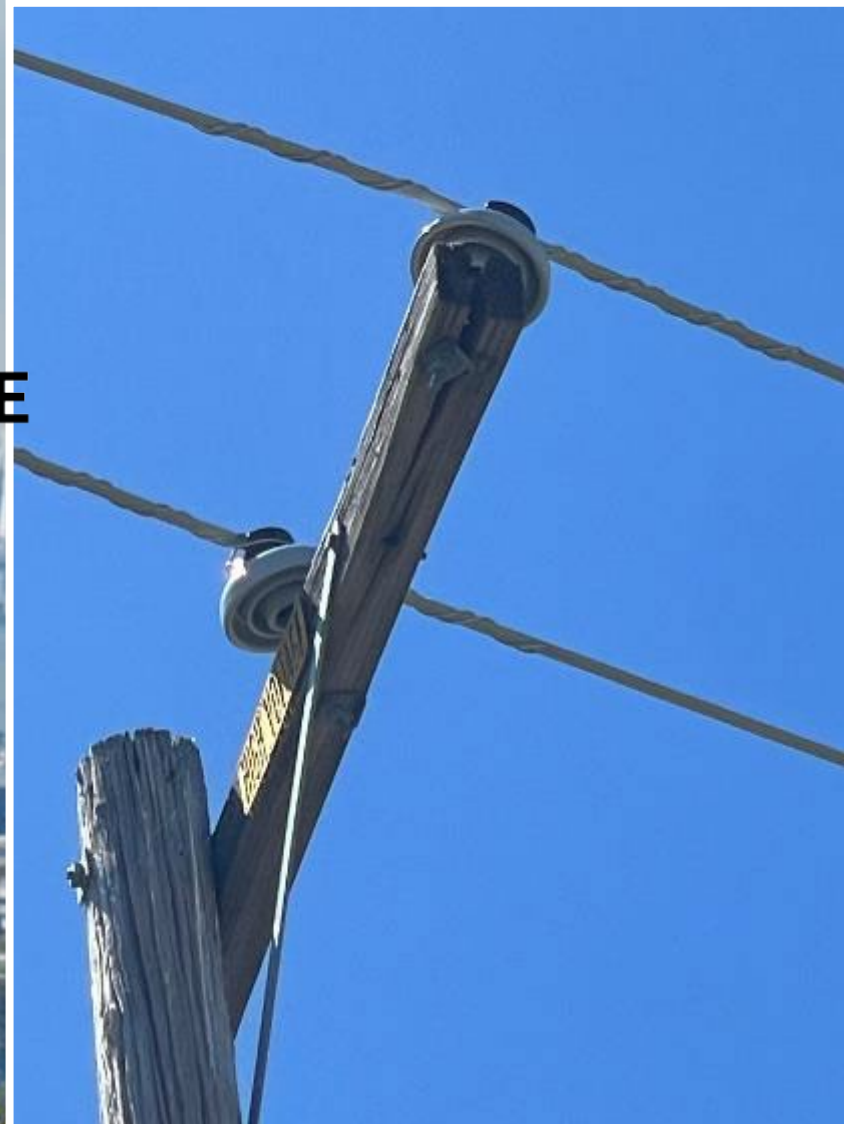
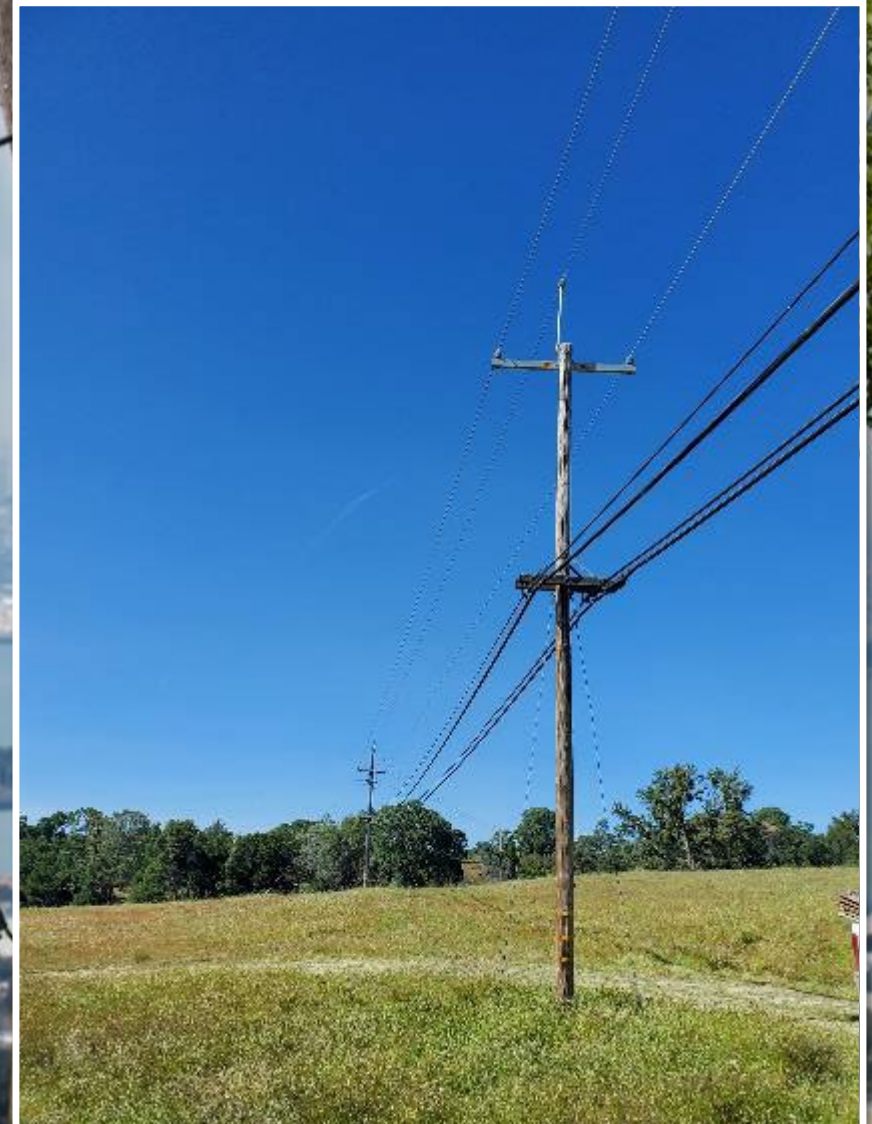
Crew noticed a broken Cross Arm on an adjacent pole from where the scheduled work was to be performed. The risk was possible wire breakage when moving wire. The crew stopped scheduled work, made the area safe and proceeded to re-frame the affected pole to correct the issue and then the crew continued the original scheduled work.

Describe the "Good Catch": What? Crew noticed broke arm on adjacent structure to where work was being done.

What was the potential risk: Hazard? While moving wire ~~off~~ onto new taller pole, could break arm and drop wire.

Action taken: Crew stopped work at current location, made area safe, and then went adjacent structure and reframed top of pole to make safe to complete original job.
