## Outside Line Weekly Newsletter

# Altec Digger Derrick Pedestal Failure: **Immediate Action Required!**

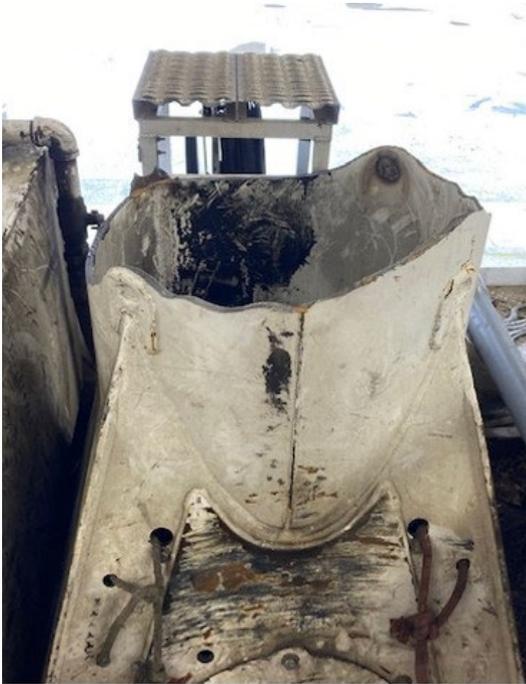
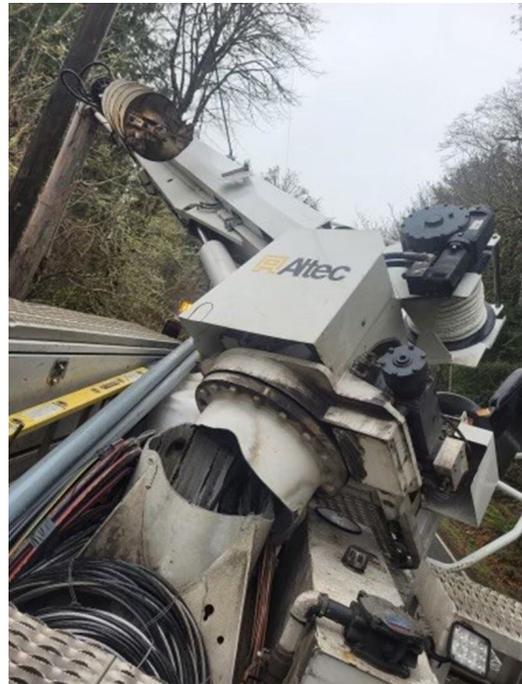
Due to this incident, a second Altec Digger Derrick has been found that shows similar metal fatigue indicators (a cracked gusset support).

To create capacity to fail safely, **the following actions** should be completed prior to using any Altec Digger Derrick truck in the field.

- When inspecting to comply with this Safety Alert, and when performing daily pre-use inspections, the Operator shall **visually inspect** the turret pedestal for any signs of metal fatigue (cracks/distortion/significant rust). Should the inspection reveal a possible defect, be sure to take pictures and report findings to your local Mechanic.

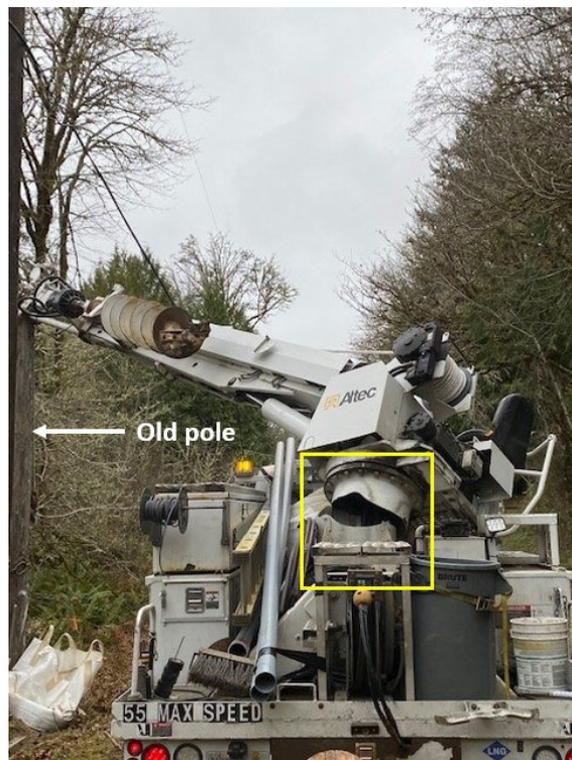
Incident: Turret failure

The crew had successfully replaced a 3-phase pole and was in the process of pulling the old cedar pole butt section that had been topped about 15' above ground. At the time of the pick at-tempt, the 2nd stage of the boom was extended about 3/4 way out and at a 35 degree angle. When applying pressure to the winchline, the old pole butt rose about 6 inches when suddenly the turret pedestal of the digger derrick broke, detaching the boom from the truck. The tip of the boom came to rest on the top of the old pole and the operators platform came to rest against a sand bag directly in front of the turret. The Foreman notified the Base Manager of the incident and a second line truck and a Mechanic was called to the scene. The second line truck removed the detached boom and loaded it on the pole trailer. There were no injuries and the incident is under investigation.

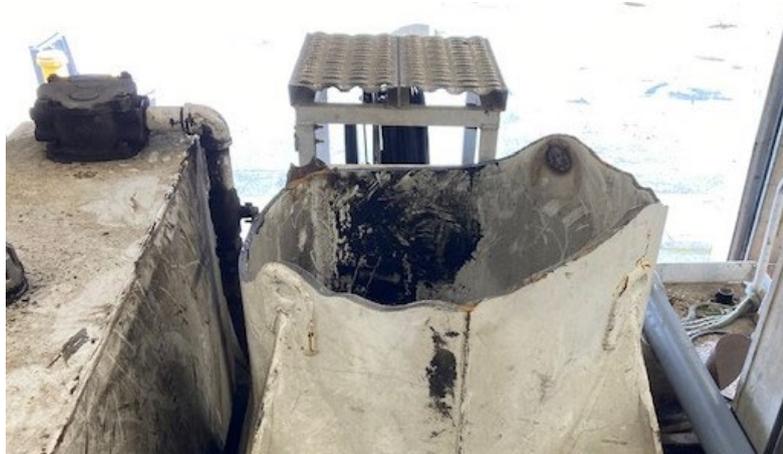
With the boom at a 35 degree angle and second stage approximately 3/4's of the way extended and a winch line rated at 13,000 LB.'s, the lift was well within its safe load parameters. In addition in 2019, the manufacturer added struts to fortify the turret pedestal for added safety capacity. In this incident, the failure was a catastrophic metal fatigue failure as indicated in the pictures. In addition, the crew practiced good situational awareness by having all other employees out of the bight and in the clear.

- Utilize best practices by using the pole butt jack to insure that the boom does not see overloading when breaking loose and removing a pole.
- Make discussing "mechanical" and gravity" energies a priority during our tailboard hazard analysis discussions.
- Booms are meant for vertical, in line lifts only without side strain. Do not use the claws to rock the pole back and forth to assist in pulling operation.
- If using the boom to lift the pole, the winch line should not be engaged (do not wind up). This ensures the hydraulic overpressure lockout is providing protection.
