26 August 2019

**USER ADVISORY**  
**IMMEDIATE ACTION REQUIRED**  
**3M™ Half Facepiece Disposable Respirators 5000 Series – Medium**

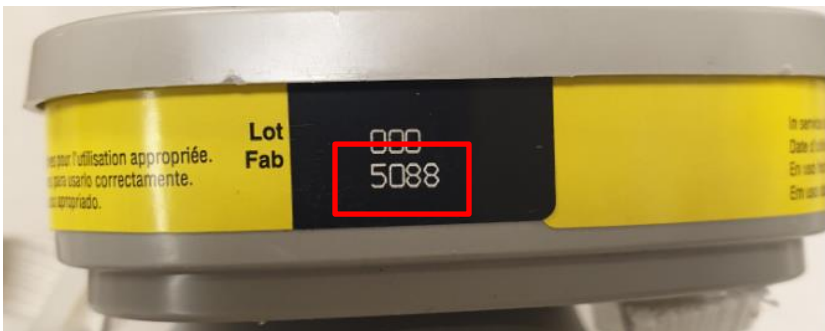
- Impacted product affected by this notice has Lot Numbers 9184 through 9204. Lot numbers can be found on the cartridges attached to the facepiece.

The above respirator is from Lot 5088

Look For: Lot Numbers 9184-9204

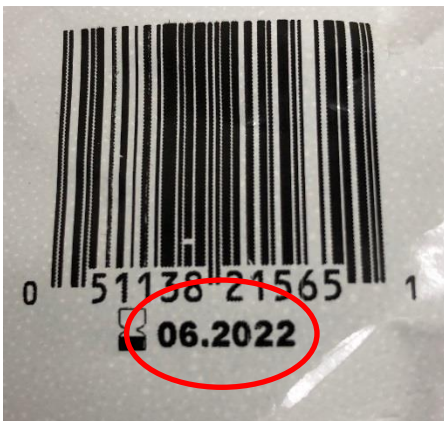
- Impacted product affected by this notice has a use-by date of 07.2024. Use-by date can be found on the back of the sealed primary bag/pouch that contains the respirator. It is a six-digit number preceded by an hourglass. The first two digits are the month and the last four digits are the year.

The use-by date above is 06.2022

Look For: Use-By Date of 07.2024

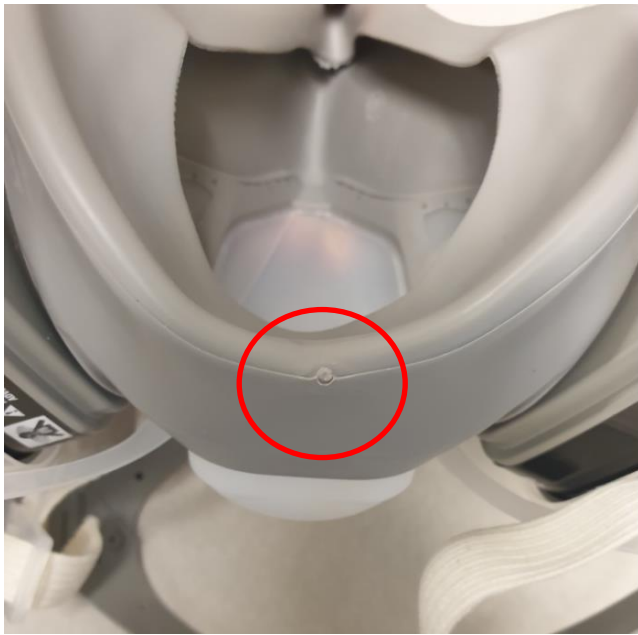
The pinholes in the respirator facepiece can be detected with a visual inspection. The images below show the location on the facepiece that is impacted. It is normal for a small nub to exist in this location of the facepiece – this is typical and is not a problem. However, a small percentage of facepieces in the lots specified above may have a small hole in that location instead of a nub.

[image of unaffected facepiece]

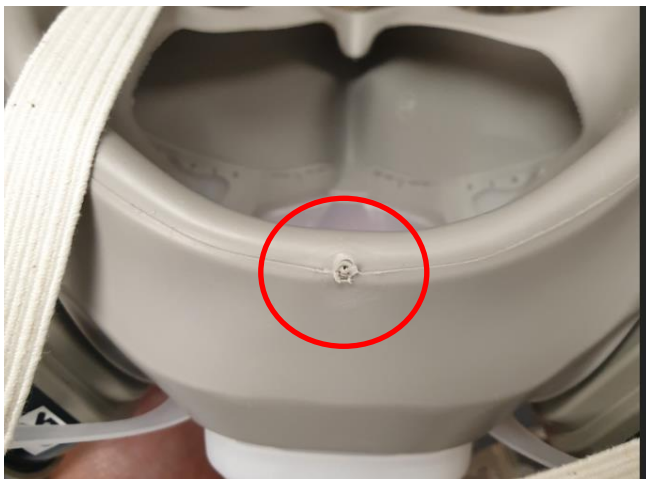
A small percentage of the facepieces in the specified respirator versions and lots may contain a pinhole in the chin area of the face seal. This may result in air leakage through the pinhole into the inside of the respirator.

[image of affected facepiece]

- A. If you find a pinhole in the respirator face seal, do not use the respirator and instead dispose of it appropriately. To request a replacement, please visit: [engage.3M.com/5000Series](https://engage.3M.com/5000Series)
- B. If no hole is visible in the respirator face seal as shown above, then the respirator can be used according to the user instructions. However, if you prefer to obtain a replacement, please visit: [engage.3M.com/5000Series](https://engage.3M.com/5000Series)
- C. Unopened impacted respirators in the model numbers and lot range specified above should be returned to 3M as soon as possible. We will provide replacements for returned impacted respirators. To return your impacted respirators and request replacements, please visit: [engage.3M.com/5000Series](https://engage.3M.com/5000Series)

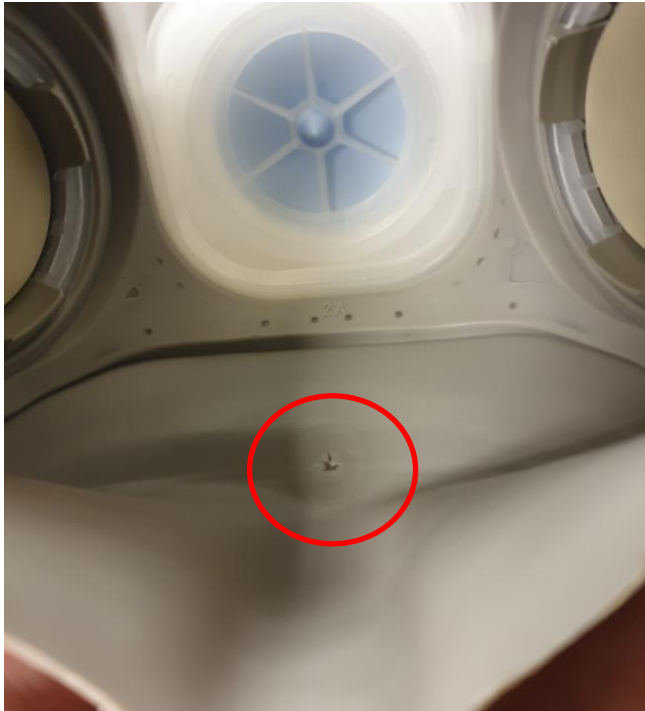
To inspect your respirator facepiece, stretch the elastomeric material in the area of the facepiece circled above by using a finger to push from inside the facepiece so the material stretches thin – as shown in the image below. Pull down the chin seal so you can see inside the facepiece. Look inside the facepiece at the area your finger has pushed inward. Look for a pinhole.
