TLine Incident Alert

Safety Advisory

Topic:	MacLean Socket ball Link_ Faulty Cotter Pin (Key)
LOB:	PG&E: Electric Operations Employees & Contractors
Initial Learnings:	<p>1.The post-incident examination and testing of the socket ball link and cotter pin at PG&E's ATS facility revealed that the cotter pine tines were not fully spread.</p> <p>2. After further analyses of several socket links and cotter pines, we have determined that MacLean socket ball link (material code 18-0189) may have faulty cotter pin configurations when distributed from the manufacture.</p> <div data-bbox="311 565 697 936">

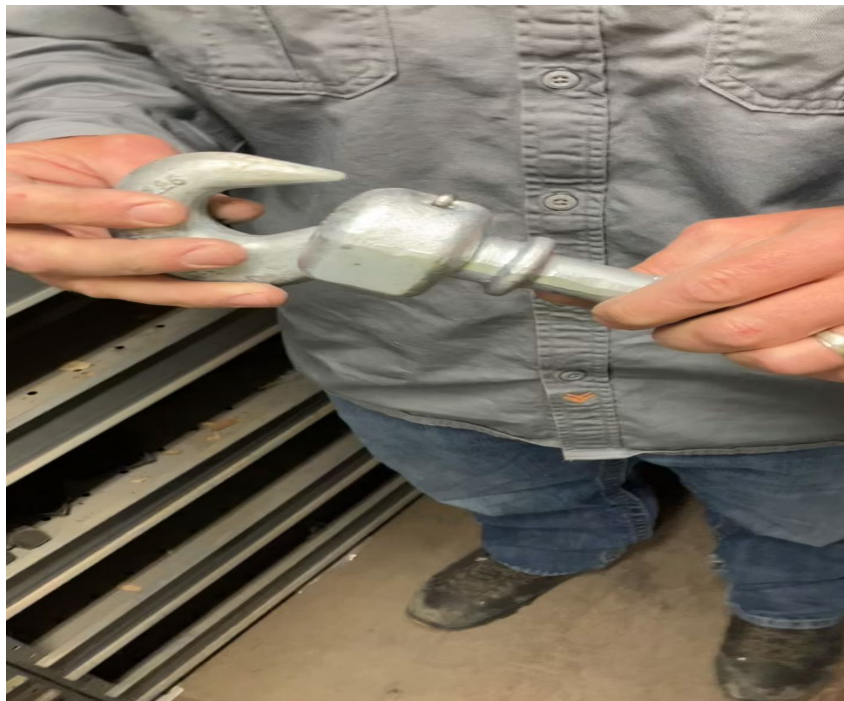
MacLean Socket Ball Link-
Video

</div> <div data-bbox="768 549 935 707"> <p>Cotter Pin Tines Not Fully Spread</p> </div>

Actions to Take:	<p>Actions:</p> <ol style="list-style-type: none"> 1. Inspect current inventory of Maclean socket ball links and remove faulty, suspect links that do not have the cotter pin fully spread. 2. All suspect MacLean socket ball links shall be removed from service and boxed up. Please contact Tyler Gayski (707) 485-4972, TBG2@PGE.com to arrange pick up. In addition, please email Tyler Gayski with current inventory of MacLean socket ball links (provide details of how many suspect socket ball links) 3. IF, available, please utilize one of our other manufactures such as Hubble or Lindsley. 4. As always, ensure a detailed inspection of all equipment is preformed prior to engaging work, this includes equipment in service. 5. Communicate this Safety Advisory to all PG&E Electric Operations Employees & Contractors.
Contact:	Tyler Gayski, Supervisor TLine Safety (TBG2)

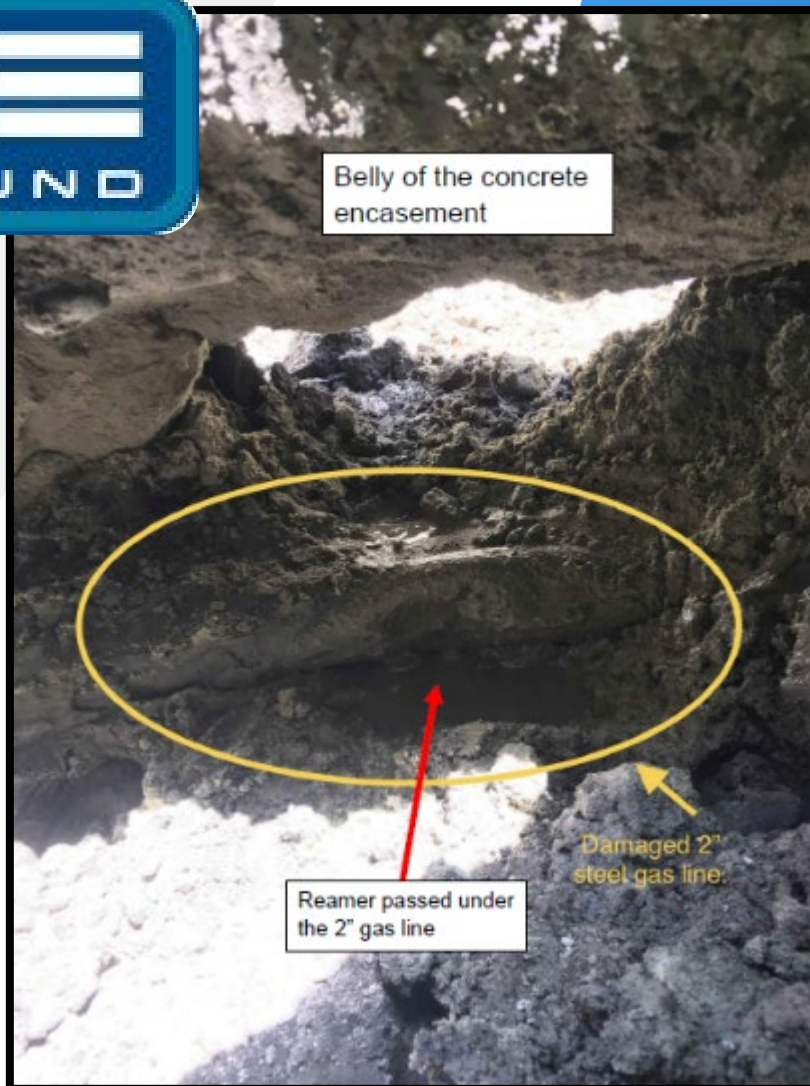
An MGE Underground civil crew was in the process of horizontal directional drilling a location in San Jose when, during the pre-reaming process, a subsurface gas installation was struck, damaged, and ruptured. The location is USA'd and was potholed. While potholing the marks placed by the gas facility locator, the pothole crew discovered a concrete encasement. Numerous attempts of potholing periphery and belly of the encasement were made, and the crew never did locate the gas facility. No attempts were made to contact the gas facility operator for more information, nor was the approximate location verified, the crew made the fateful assumption that the subsurface gas installation was in the concrete encasement. This assumption quickly unraveled when they discovered the gas line during the pre-reaming process – ultimately causing significant damage to the gas facility.

Stock photo of JT30 used when dig-in occurred

Below - 16" Borzall Tornado Reamer – component that contacted the 2" steel gas line

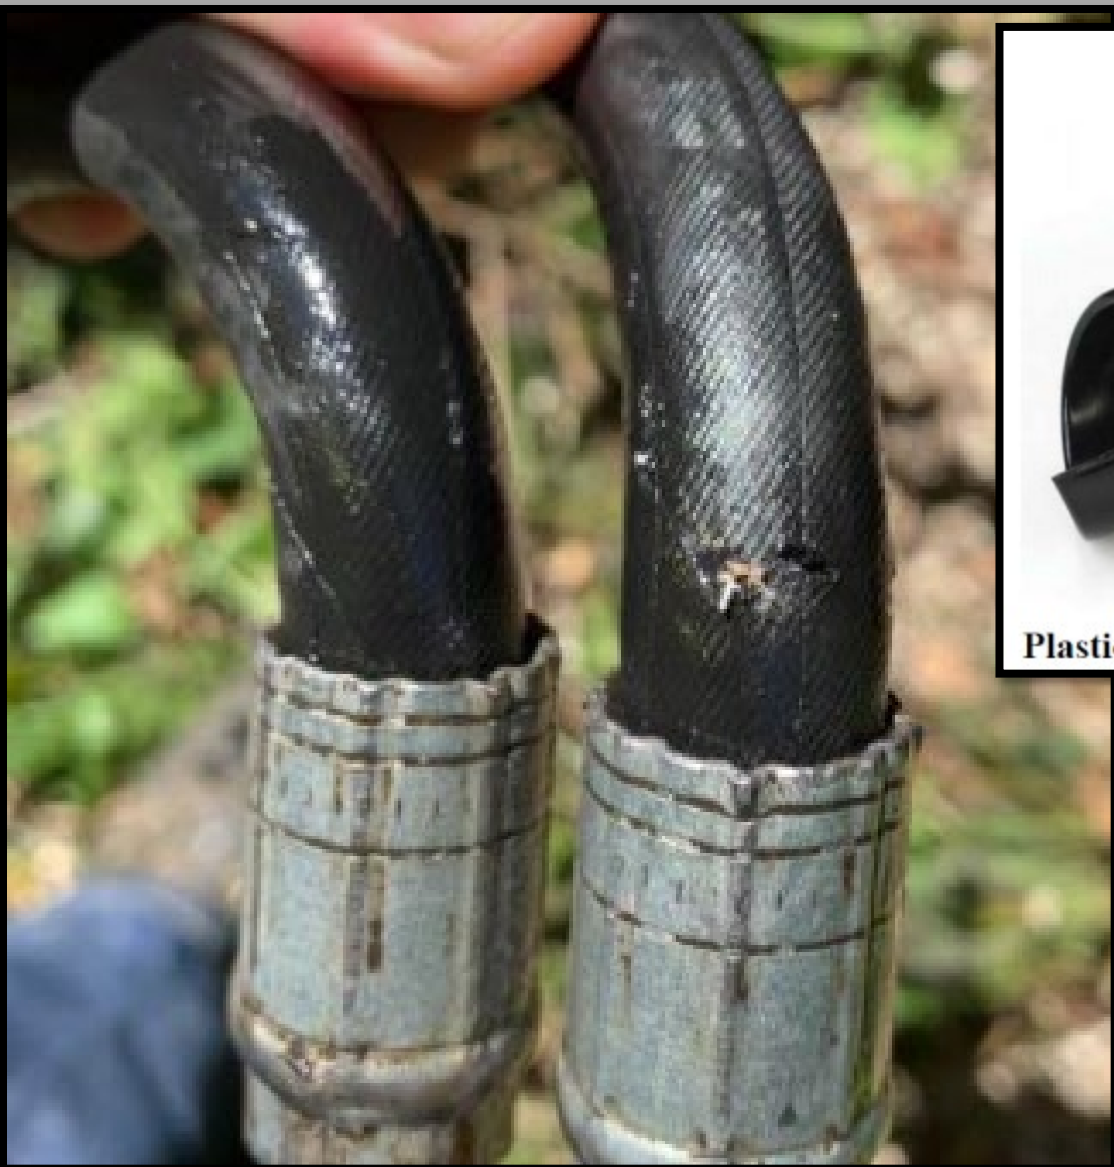
Plastic Spiral Wrap

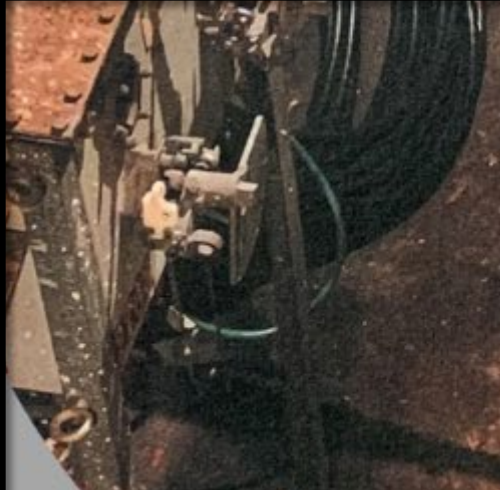
Kevlar Sleeve/Hose Protector

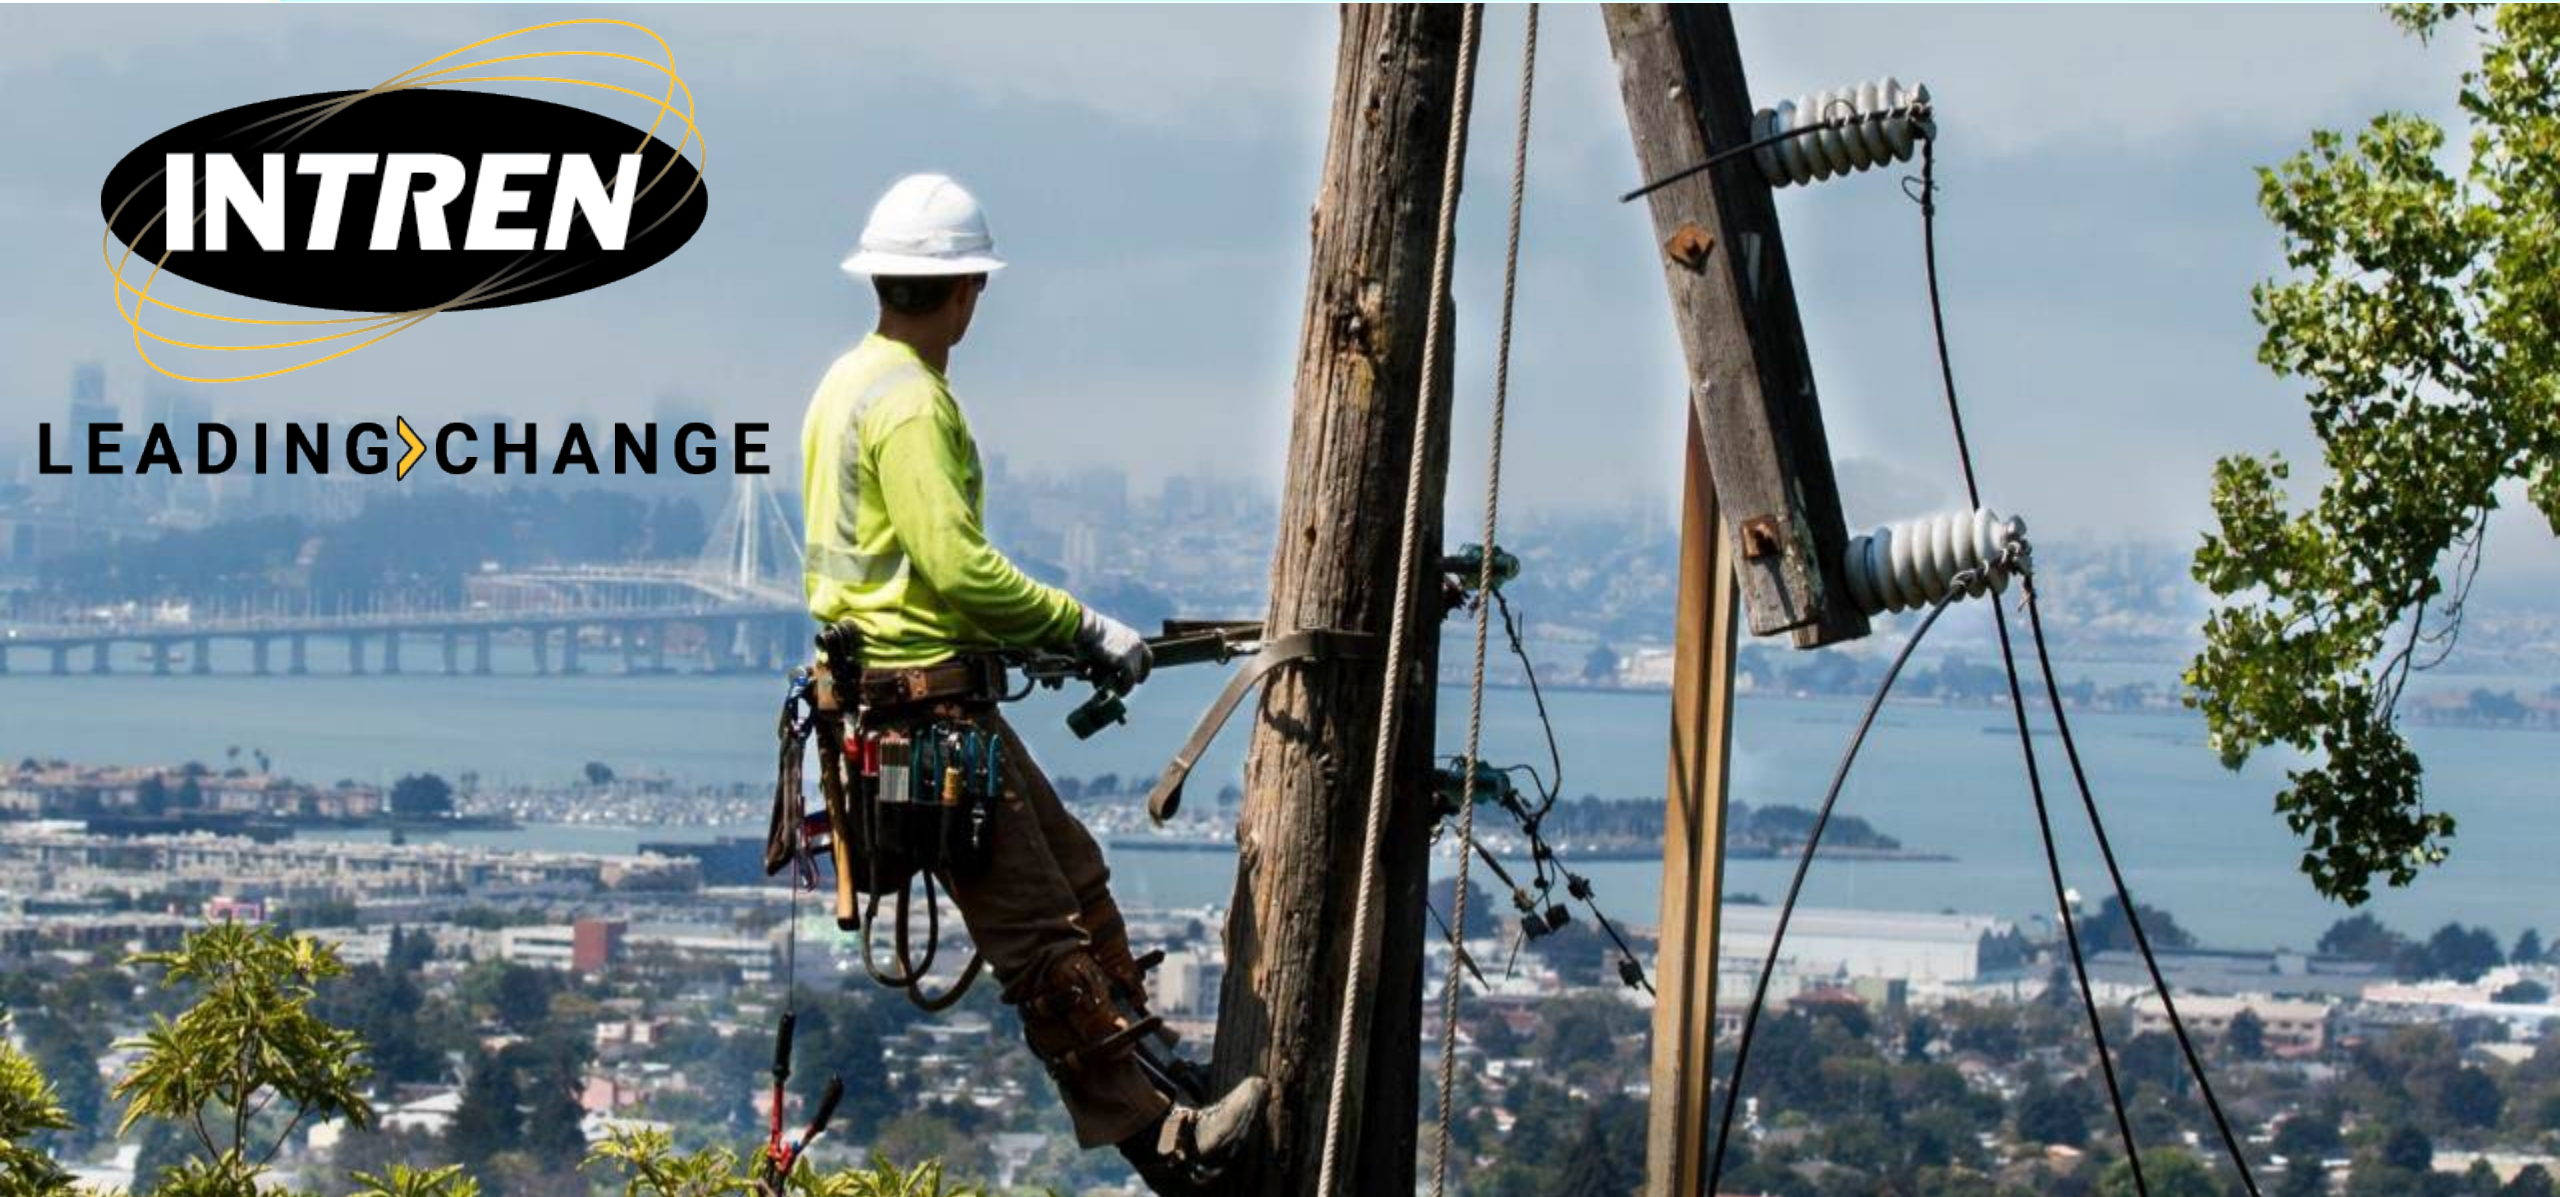
5/13/2022 – INTREN – Good Catch – Plymouth – Aaron Meeke

Crew noticed a broken Cross Arm on an adjacent pole from where the scheduled work was to be performed. The risk was possible wire breakage when moving wire. The crew stopped scheduled work, made the area safe and proceeded to re-frame the affected pole to correct the issue and then the crew continued the original scheduled work.

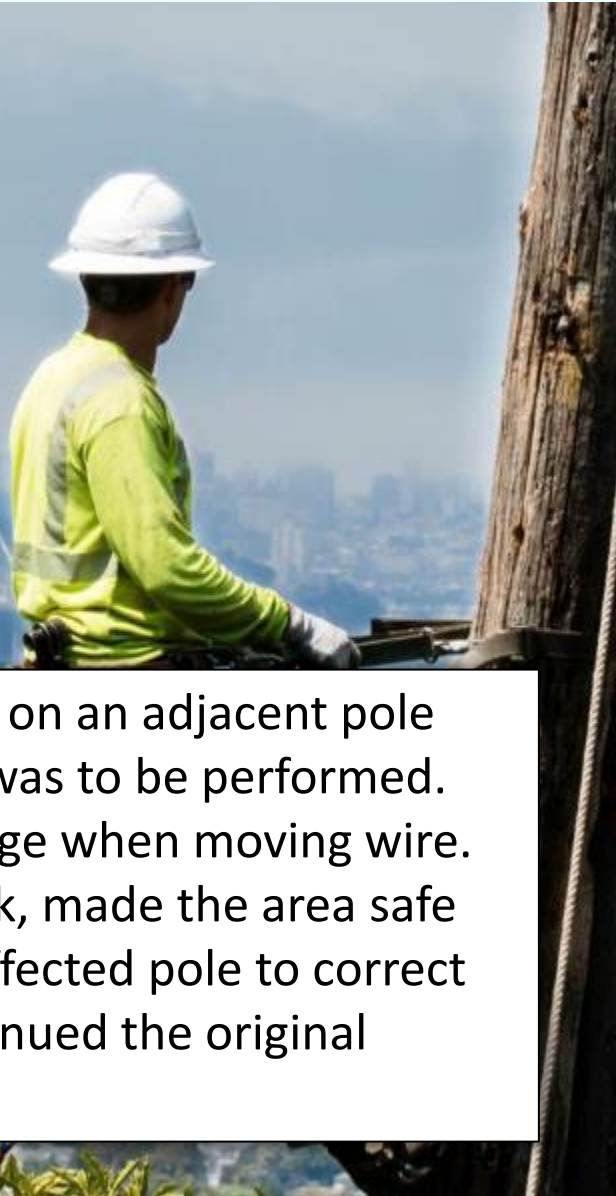
Good Catch Reporting

Describe the "Good Catch": What? Crew noticed broke arm on adjacent structure to where work was being done.

What was the potential risk: Hazard? While moving wire ~~off~~ onto new taller pole, could break arm and drop wire.

Contributing factors of good catch: Why? Was brought up in tailboard to inspect adjacent structures.

Action taken: Crew stopped work at current location, made area safe, and then went adjacent structure and reframed top of pole to make safe to complete original job.
