## Outside Line Weekly Newsletter

# Altec Digger Derrick Pedestal Failure: **Immediate Action Required!**

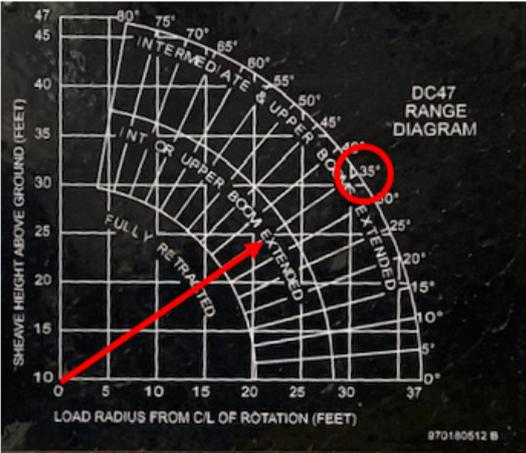
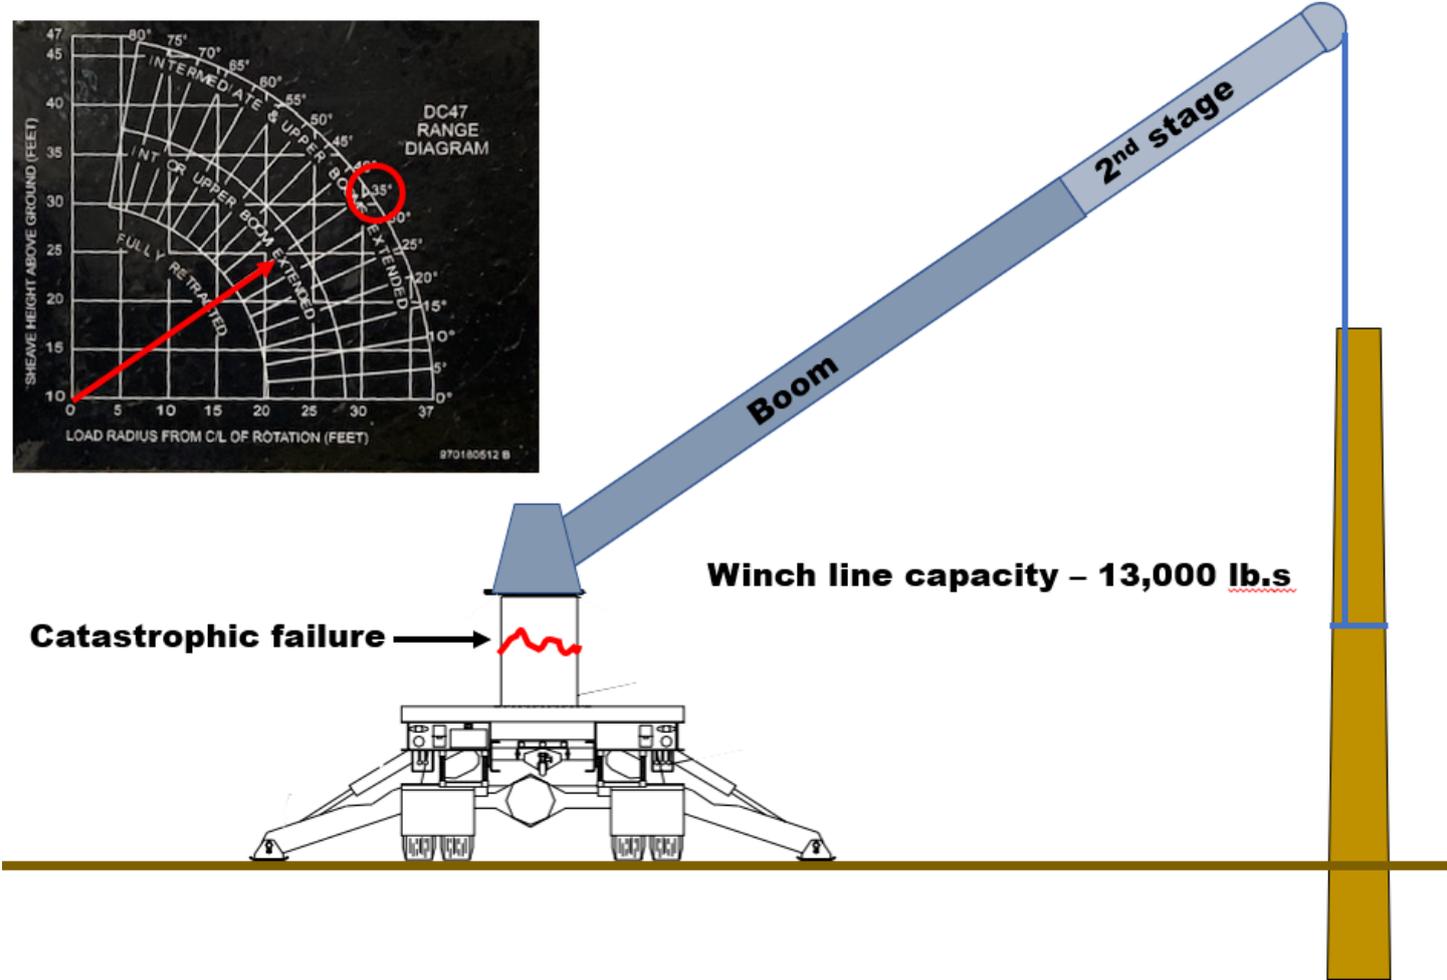
Incident: Turret failure

FYI a Chapter Member recently had a catastrophic boom failure incident that could have resulted in a life-threatening outcome. Fortunately, there were no injuries, and the incident is under further investigation.

Due to this incident, a second Altec Digger Derrick has been found that shows similar metal fatigue indicators (a cracked gusset support).

The crew had successfully replaced a 3-phase pole and was in the process of pulling the old cedar pole butt section that had been topped about 15' above ground. At the time of the pick at-tempt, the 2nd stage of the boom was extended about 3/4 way out and at a 35 degree angle. When applying pressure to the winchline, the old pole butt rose about 6 inches when suddenly the turret pedestal of the digger derrick broke, detaching the boom from the truck. The tip of the boom came to rest on the top of the old pole and the operators platform came to rest against a sand bag directly in front of the turret. The Foreman notified the Base Manager of the incident and a second line truck and a Mechanic was called to the scene. The second line truck removed the detached boom and loaded it on the pole trailer. There were no injuries and the incident is under investigation.

With the boom at a 35 degree angle and second stage approximately 3/4's of the way extended and a winch line rated at 13,000 LB.'s, the lift was well within its safe load parameters. In addition in 2019, the manufacturer added struts to fortify the turret pedestal for added safety capacity. In this incident, the failure was a catastrophic metal fatigue failure as indicated in the pictures. In addition, the crew practiced good situational awareness by having all other employees out of the bight and in the clear.

- When inspecting to comply with this Safety Alert, and when performing daily pre-use inspections, the Operator shall **visually inspect** the turret pedestal for any signs of metal fatigue (cracks/distortion/significant rust). Should the inspection reveal a possible defect, be sure to take pictures and report findings to your local Mechanic.

- Utilize best practices by using the pole butt jack to insure that the boom does not see overloading when breaking loose and removing a pole.
- Make discussing "mechanical" and gravity" energies a priority during our tailboard hazard analysis discussions.
- Booms are meant for vertical, in line lifts only without side strain. Do not use the claws to rock the pole back and forth to assist in pulling operation.
- If using the boom to lift the pole, the winch line should not be engaged (do not wind up). This ensures the hydraulic overpressure lockout is providing protection.
