# SIF Alert: FINAL communication

<b>Title:</b>	Vacaville Driver Fatigue MVI CONT H&M CAP# 121939533
<b>Purpose:</b>	Reviewing the evaluation from this Serious Injury and Fatality (SIF) Potential incident will allow us to learn what organizational improvements need to be made to ensure job task hazard controls provide workers greater capacity to perform their work safely. The findings of the incident are detailed below and include the corrective actions intended to minimize the likelihood of another similar incident occurring. To increase the awareness of hazards and share lessons learned, please inform your employees of the incident takeaways at your next safety tailboard.
<b>Incident summary:</b> <b>CAP 121939533</b>	On Saturday, August 21, 2021, a Henkels & McCoy journeyman lineman was driving a company-owned vehicle (Digger Derrick) with a trailer east on I-80 near the intersection of Davis St. in Vacaville, CA, when the employee fell asleep and exited the roadway. The driver awoke when the vehicle collided with the right metal guardrail and concrete barrier that continued the roadway's shoulder. The vehicle slid along the top of the guardrail, causing it to tip onto its side b

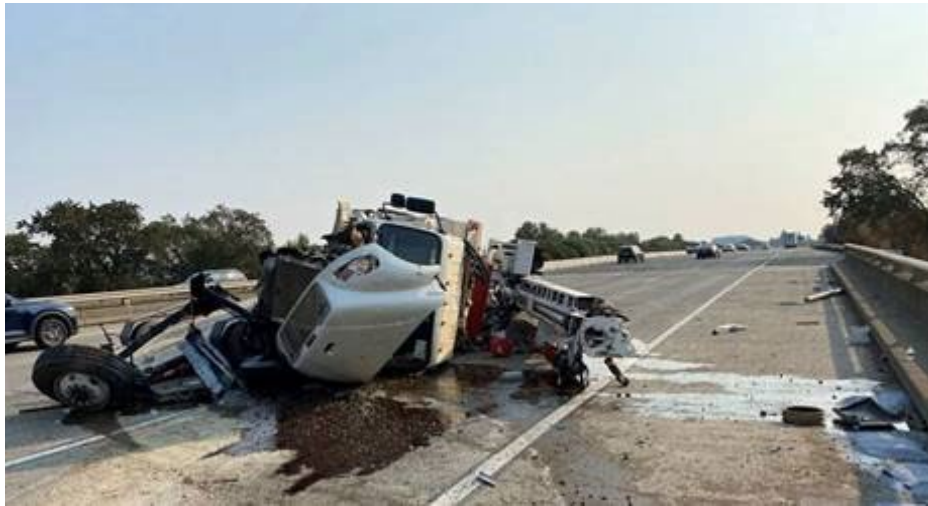
<b>Cause:</b>	<ol style="list-style-type: none"> <li>1. Henkels &amp; McCoy lacks a compressive fatigue management process for their crews working extended hours performing routine emergency work.</li> <li>2. The PG&amp;E contractor did not follow the required hours-of-service regulations for routine work and have a fatigue management procedure in place when requested to complete Emergency Restoration of Service (ERS) "A" Tag within Electric Operations.</li> </ol>
<b>Summary of findings:</b>	<ul style="list-style-type: none"> <li>• The vehicle involved in the accident was a 2018 model not equipped with a lane departure warning device or airbags (not required)</li> <li>• The driver fell asleep behind the wheel after working 27 hours</li> <li>• The H&amp;M driver fatigue management process was informal (limited development)</li> </ul>
<b>Corrective actions summary:</b>	<ul style="list-style-type: none"> <li>• Henkels &amp; McCoy (H&amp;M) will create a written fatigue management policy that includes the foreman contacting the general foreman if the crew is expected to exceed a 16-hour work period.</li> <li>• H&amp;M will incorporate their revised fatigue management policy into their onboarding and annual employee safety refresher training.</li> <li>• H&amp;M will revise their JSA tailboard to perform and document a fatigue management assessment with crews at the 16th hour of an extended work period and at a minimum duration (e.g., 4hrs., 8hrs., etc.) afterward. Discussion should include, at a minimum, each crew member's fatigue level and their ability to continue working safely.</li> <li>• H&amp;M will revise their Programmatic Safety Plan (PSP) to include information on physical exhaustion, long hours, and fatigue.</li> <li>• PG&amp;E Transportation Safety &amp; Regulatory will develop and house on a SharePoint the following documents: <ol style="list-style-type: none"> <li>1. Safety Advisory for Contractors to help them understand Hours of Service (HOS) regulations for both normal business and for the Emergency Restoration of Service (ERS) "A" Tag within Electric Operations.</li> <li>2. Safety Advisory for PG&amp;E contract administrators and other PG&amp;E personnel to help them understand Hours of Service regulations for both normal business and for the Emergency Restoration of Service (ERS) "A" Tag within Electric Operations.</li> <li>3. Emergency Restoration of Service Declaration to be added to all Electric "A" tags which provides the following requirement of the CA, CVC 34501. <ol style="list-style-type: none"> <li>a. Scope and duration</li> <li>b. Required documentation</li> </ol> </li> </ol> </li> </ul>

Photograph of the Digger Derrick with trailer resting in the middle of I-80 freeway, facing the opposite direction of traffic.

- c. Logbook requirements
- d. Fatigue management policy requirements
- e. Once work is complete, 34-hour HOS reset requirement
- Construction Resource Management will:
  1. Develop a communication to all contractors that perform Emergency Restoration of Service (ERS) for PG&E and provide them with Commercial Driver Fatigue Management procedure TRAN-2001P-01.
  2. Develop an internal communication for all PG&E electric personnel that have contractors work ERS as part of their contract. The communication will provide:
    - o Links to Commercial Driver Fatigue Management procedure TRAN-2001P-01, California Code, Vehicle Code - VEH § 34501.2, and Section 218 of the Public Utilities Code
    - o Instructions on how the “Emergency Restoration of Service Declaration” will be added to any contractor A-tag going forward

- Contractors performing emergency restoration work under the work hour limit exemption category need to comply with all Emergency Restoration of Service (ERS) “A” Tag fatigue management requirements. This incident has provided PG&E with an improved understanding of what more is needed to ensure our contractors abide by these fatigue management requirements.
